MY FLEET

1972 ROVER 3500S
'CHRISTINE'

Phoenix from the ashes

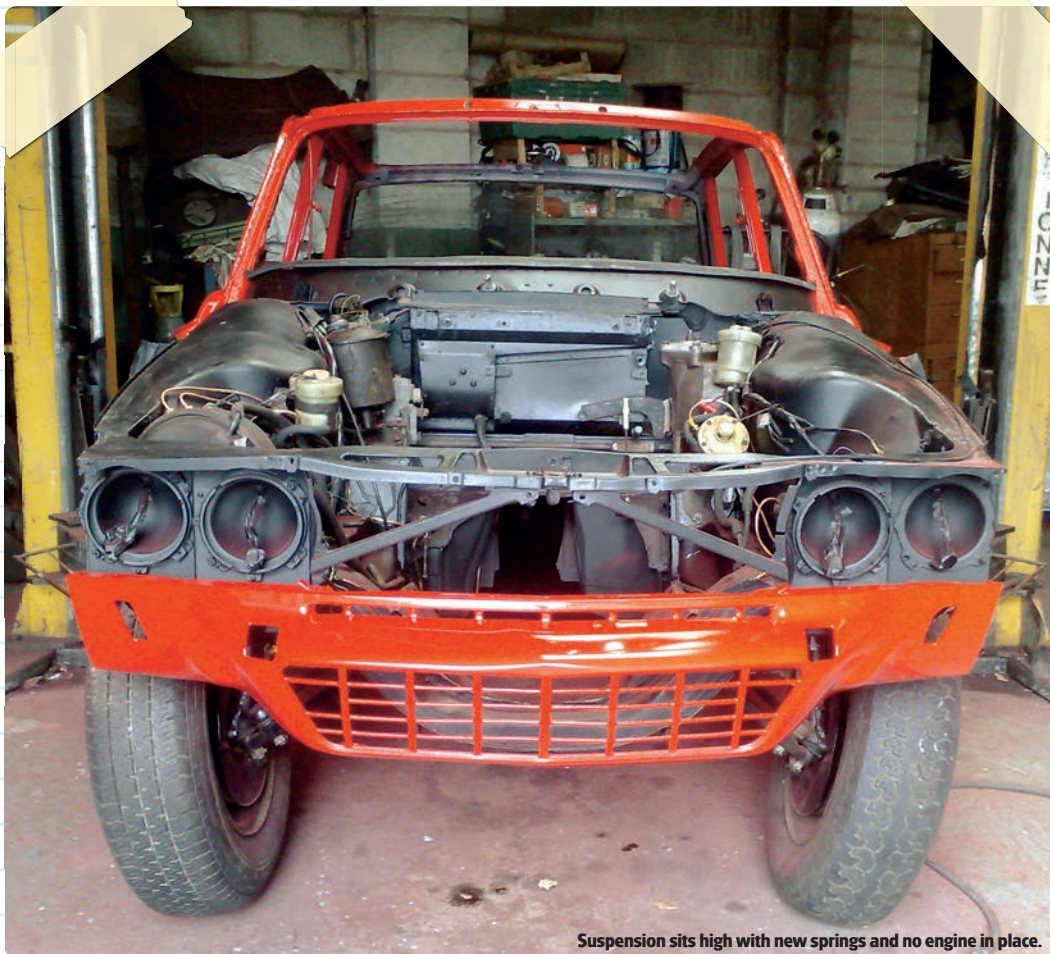
Suspension sits high with new springs and no engine in place.

was quickly welded into place. Priming and painting the bodyshell followed. Mark's daughter Maria painted many suspension parts, which were then fitted with Superpro bushes (www.superpro.eu.com).

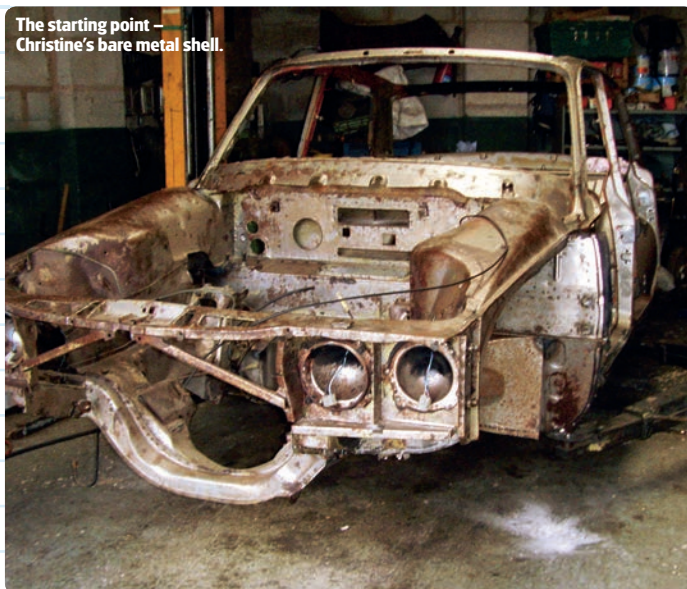
The starting point - Christine's bare metal shell.

Mark started by repairing the holes in the floor. Luckily his spares stock included a suitable rain gutter to replace the one that had rotted away, so that

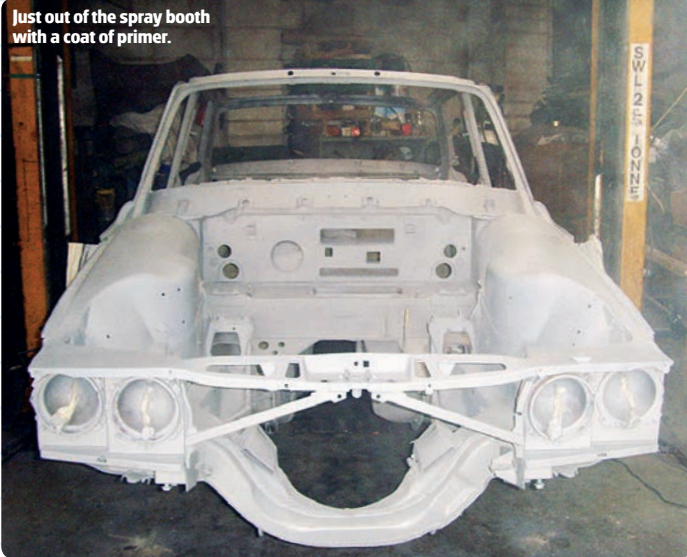
Just out of the spray booth with a coat of primer.

The base unit was finished in the original Monza Red, then began the rebuild. I say rebuild though in reality this is now a

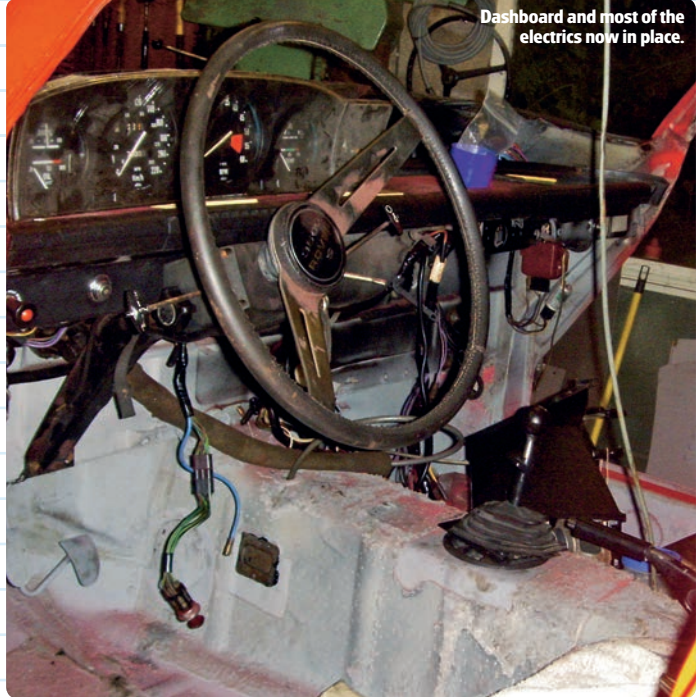
Dashboard and most of the electrics now in place.

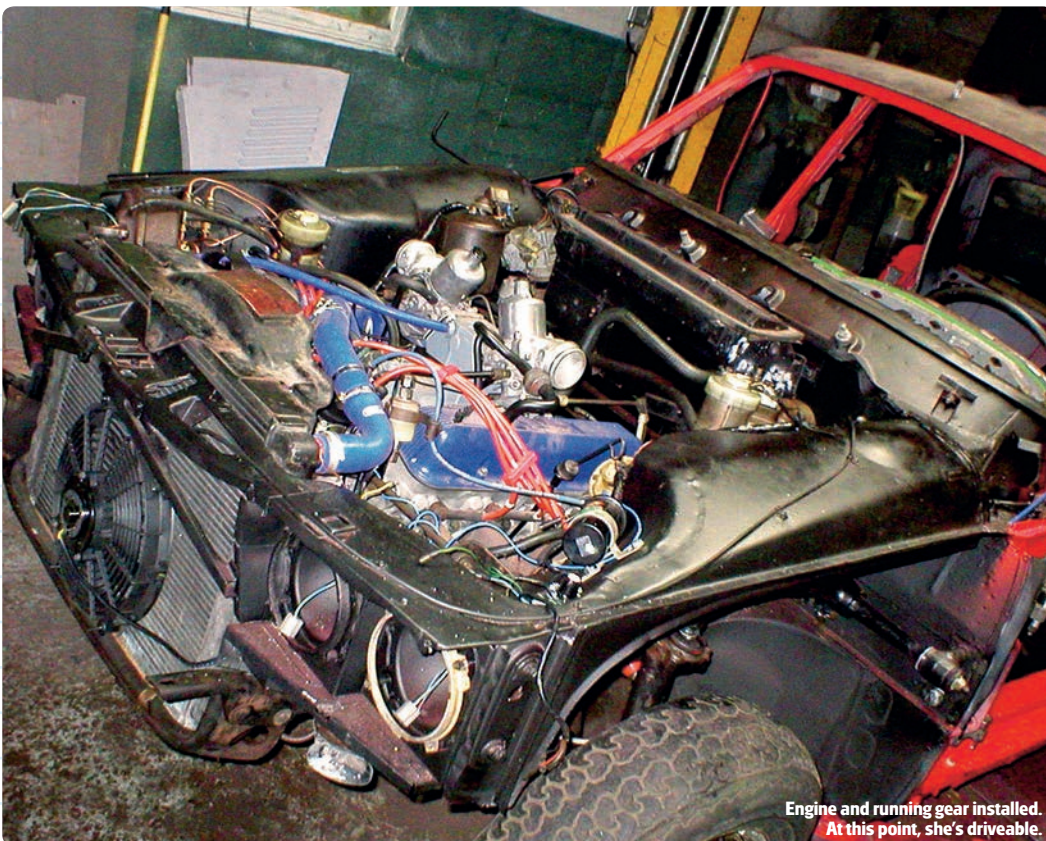
Engine and running gear installed. At this point, she's driveable.

At present, Christine's fully driveable. Mark's booking an MOT for the next week and is confident of a pass first time. I honestly can't wait. **CM**
